Study of foundations in Ukraine from the eleventh to eighteenth centuries and their preservation and conservation methods: Experiences

Muzeológia a kultúrne dedičstvo, 2022, 10:1:33-51
DOI: 10.46284/mkd.2022.10.1.3

Keywords: archaeological research, architectural monuments, foundations, structural schemes, Kyivan Rus.

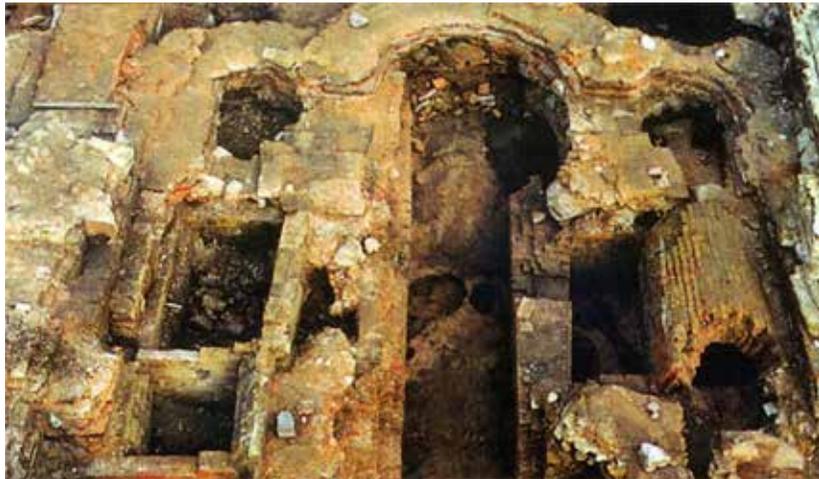
Fig. 1: Fragment of ancient foundations of St Michael's Golden-Domed Cathedral.
Photo: [in:] Collection of the Ukrrestavratsiia Corporation

plates fastened with iron pins and grouted with mortar with powdered overburnt brick. The foundation ditches were filled with rubble stone and grouted with the mortar with powdered overburnt brick, the colour of which was slightly lighter than the colour of the cathedral walls. As a result of archaeological research, it was established that the foundations of the cathedral featured a cross strip system of brick and rubble masonry, and at the intersection of the strips, there isolated column foundations were found (Fig. 1).

The foundations of the Old Russian core of St Michael's Golden-Domed Cathedral were made of large rubble stone bound by *opus signinum* mortar. Upwards splayed foundation ditches were dug for these foundations, the bottom of which were reinforced with wooden sill

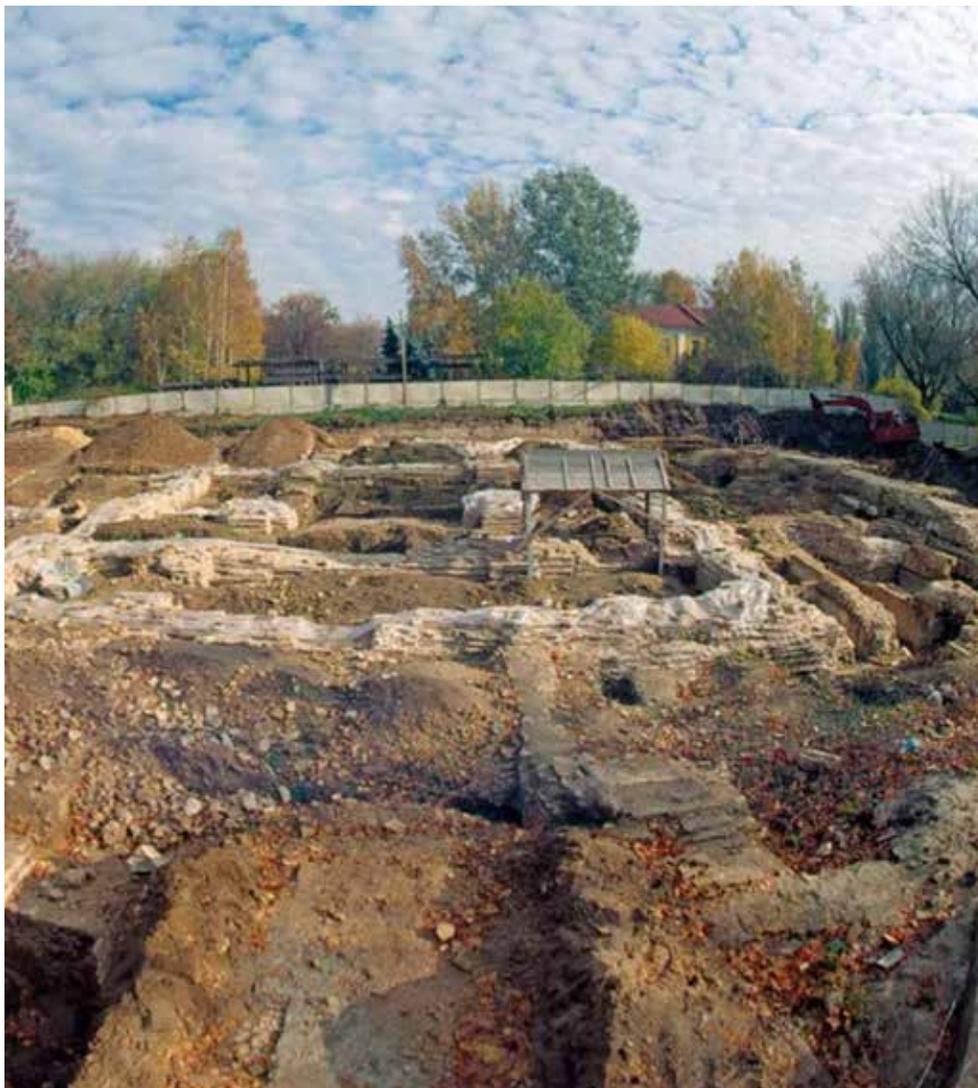
Fig. 2: *Ancient foundations of St Michael's Golden-Domed Cathedral.* Photo: [in:] Collection of the Ukrrestavratsiia Corporation

5–20 cm boulders) with lime mortar; while the top layer (0.4–0.8 m) was made up of plinthiform bricks and lime mortar⁷ (Fig. 2).

Strip foundations from between the eleventh and the thirteenth centuries were made in the form of brick and lime and lime-clay mortar, with stones in column and strip foundations left unbound (Fig. 2).

The Old Russian foundations from the twelfth century consisted of a layer-by-layer structure, where the lower layer (1.2–1.5 m) was composed of cyclopean masonry consisting of irregularly shaped stone blocks with sizes ranging between 20 and 70 cm without mortar (moreover, the cavities between the stones were filled with local soil); and the intermediate layer (0–0.5 m) consisted of rubble and cement masonry (from crushed plinthiform bricks and

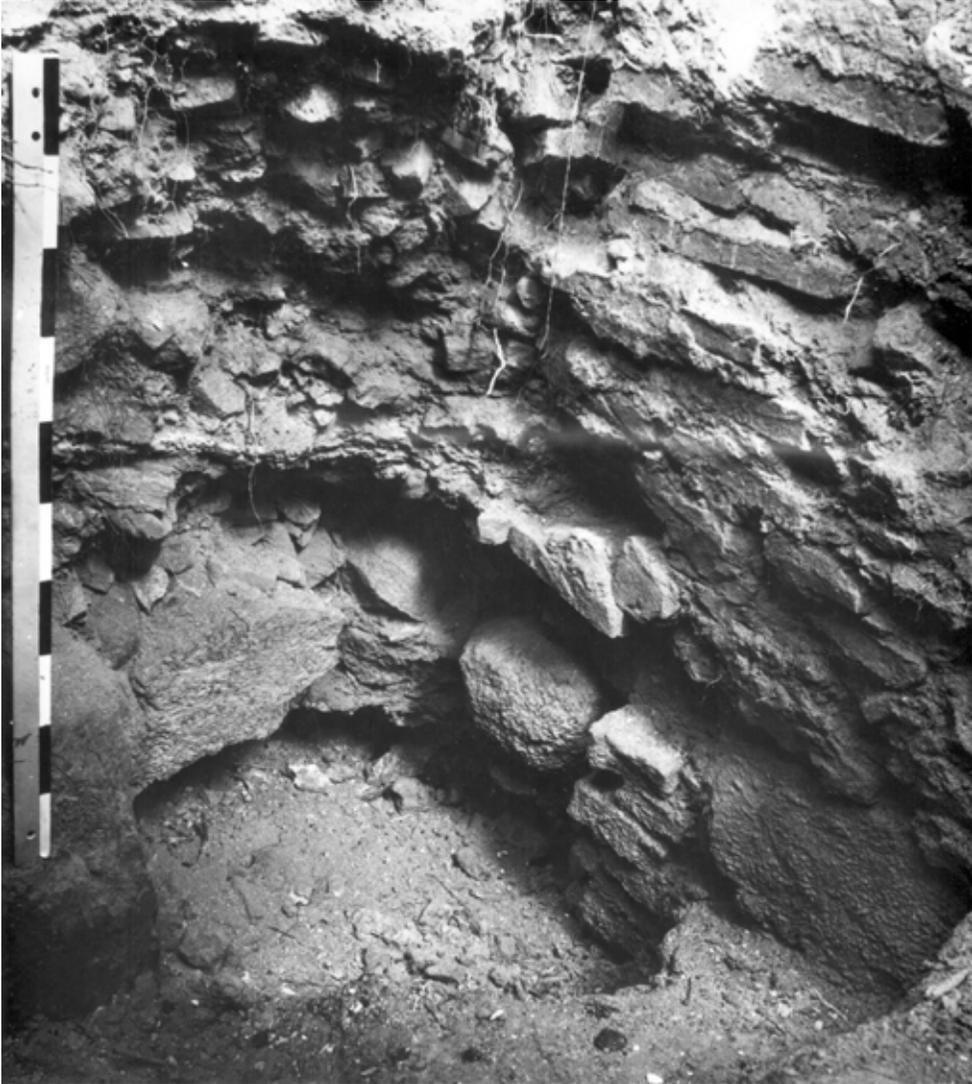
The remains of the foundation masonry of the cathedral represent a cross-strip system, made of brick and rubble masonry (Fig. 3).

Fig. 3: *Ruins of old masonry foundations of St Michael's Golden-Domed Cathedral.* Photo: [in:] Collection of the Ukrrestavratsiia Corporation

The crossing points of the strips form pillars – the foundations of the columns. The cross-section of the twelfth-century foundations formed a layer-by-layer structure: the upper layer, from 0.4 to 0.8 m thick, consisted of plinthiform brick with lime mortar; the middle layer – up to 0.5 m – was rubble cement masonry and lime mortar, while broken plinthiform bricks and

irregularly shaped stone blocks ranging in size between 5 to 20 cm were used as infill. The bottom layer, from 1.2 to 1.5 m, consisted of cyclopean masonry with 20 to 70 cm irregularly shaped stone blocks without mortar. As noted above, the gaps between the stones were filled with local soil.

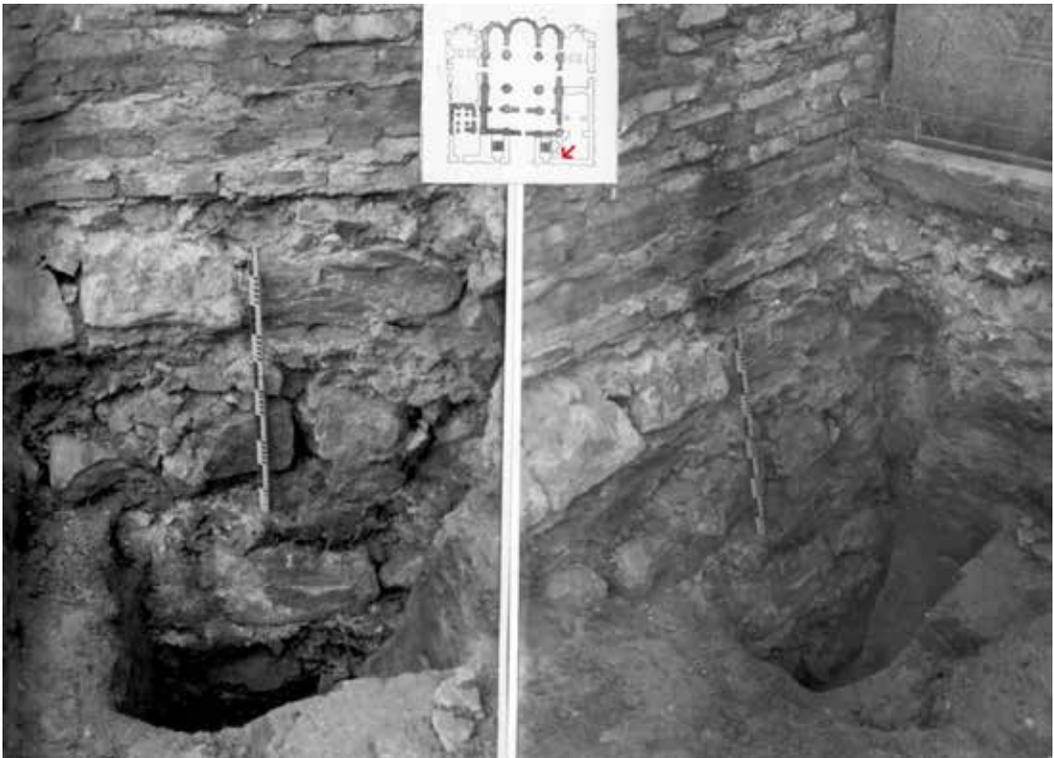
Fig. 4: *The Dormition Cathedral. Excavation site no. 20 b. Pit in the north-western corner of the southern vestibule to determine the footing level.* Photo: [in:] Collection of the Ukrrestavrtsiia Corporation.

The foundations of the northern apse expanded inward, and their lower part was composed of large dry stones. The dimensions of the stones from which the foundations were made in the north-western part of the cathedral increased along with footing level. As mentioned earlier, according to the studies carried out, the following, higher-precision periodisation of the construction of the cathedral was adopted: first period (1073–1109), second period (between 1109 and the second half of the twelfth century), third period (between the thirteenth and the fifteenth centuries), fourth period (between the sixteenth century and the 1630s), fifth period (1638–1677), sixth period (between the 1690s and 1718), seventh period (1718–1780)¹³ (Fig. 4).

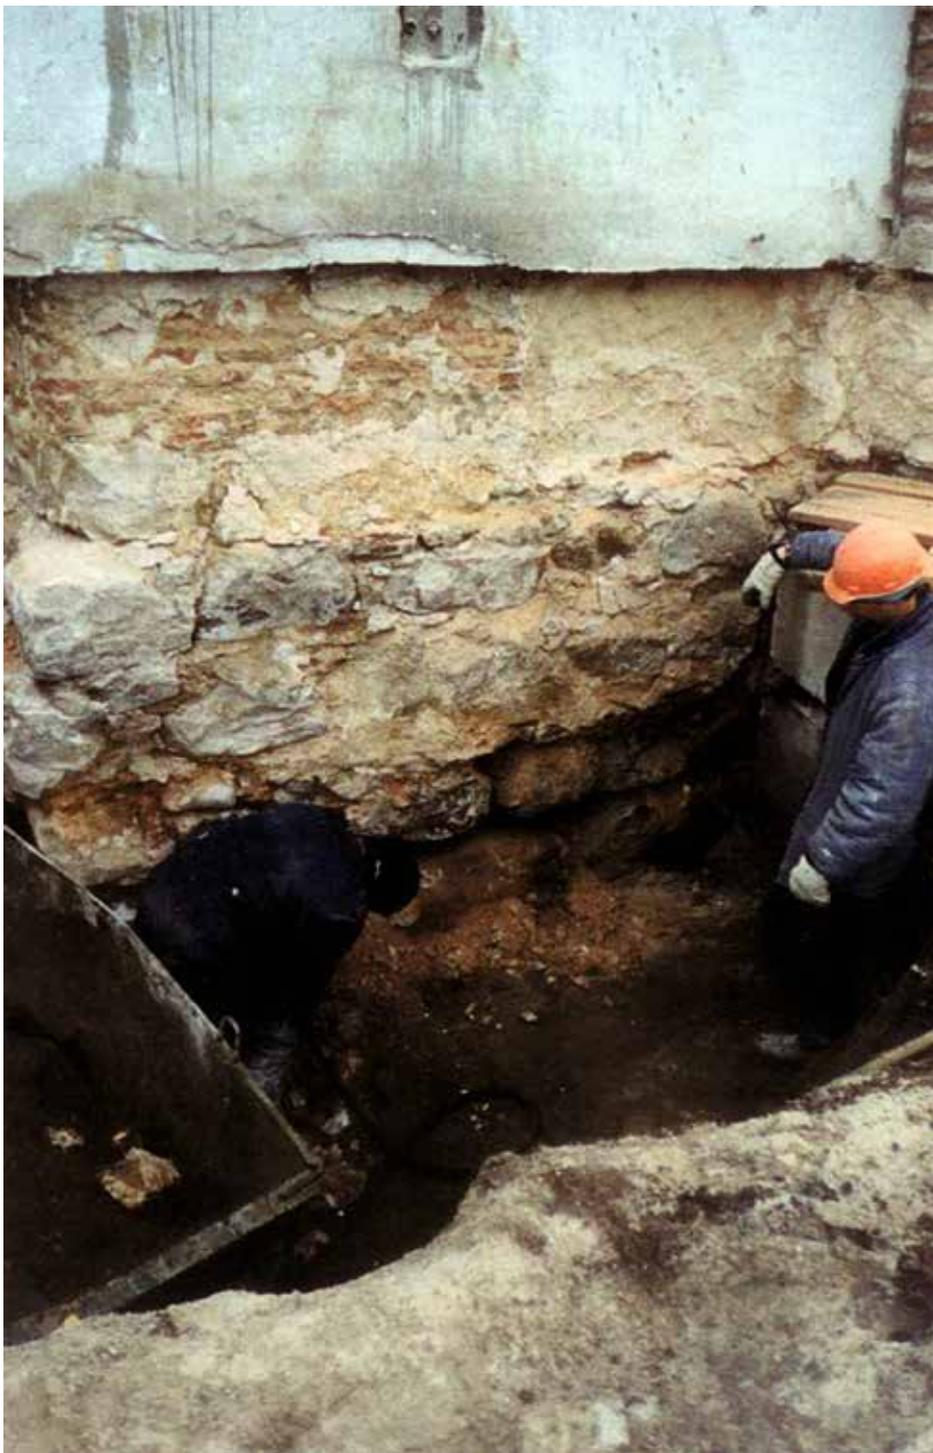
nique and with a recessed course, using stones of significant size (Fig. 5). At certain levels, the masonry of the Dormition Cathedral was dissected by peculiar reinforcing strips in the form of flat slabs of dark red Ovruch slate. For the surface structure of the cathedral and the back-filling of the foundations, a light pink lime mortar with powdered, high-density, high-strength overburnt brick was used.

Fig. 5: *Fragment of ancient foundations of the Dormition Cathedral.* Photo: [in:] Collection of the Ukrrestavratsiia Corporation

Within each period, several stages were identified and the nature and characteristics of each of them were formulated. In the first period of construction, three stages were distinguished: 1073–1087, 1088–1089 and between the 1090s and 1109. In the first stage, the masonry of the original massing of the cathedral was made of plinthiform brick, using the *opus mixtum* tech-

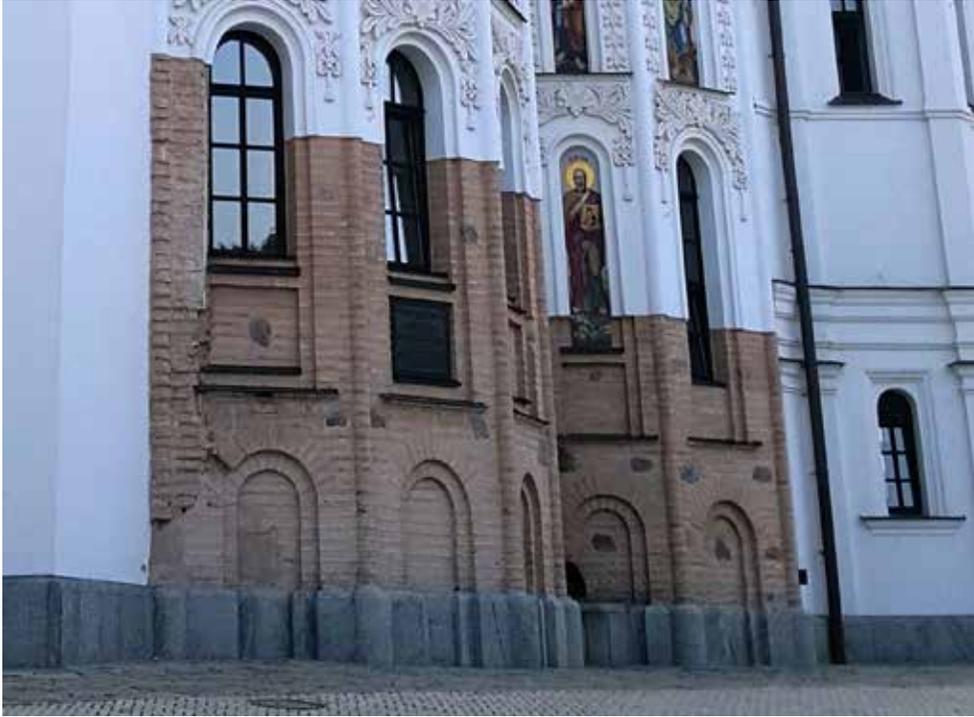
Fig. 6: Reconstruction of old masonry techniques on the apses of the Dormition Cathedral. Photo by D. Kuśnierz-Krupa, 2019

Over the past decades, restoration work has been carried out on St Michael's Golden-Domed Monastery, the Holy Dormition Cathedral of the Kyiv-Pechersk Lavra (Fig. 6), the Pyrohoshcha Dormition of the Mother of God Church in Podil, the monument to Princess Olga and Saints Cyril and Methodius, and St Vladimir's Cathedral in Chersonesos, which are of great importance as symbols of Ukrainian statehood as examples of the architecture of their respective periods. Of many unique monuments, only their foundations remained (the Church of the Tithes, the Pyrohoshcha Dormition of the Mother of God Church in Podil, St Michael's Golden-Domed Cathedral with a bell tower); in some, in addition to the foundations, walls and individual fragments remained (St Vladimir's Cathedral in Chersonesos, the Dormition Cathedral of the Kyiv-Pechersk Lavra). In this case, the main restoration task was the maximum preservation of artifacts – foundations, walls, aisles and chapels. In the process of reproduction, the task was to provide access to the historical foundations for further research and observation by visitors (St Michael's Golden-Domed Cathedral) wherever possible.

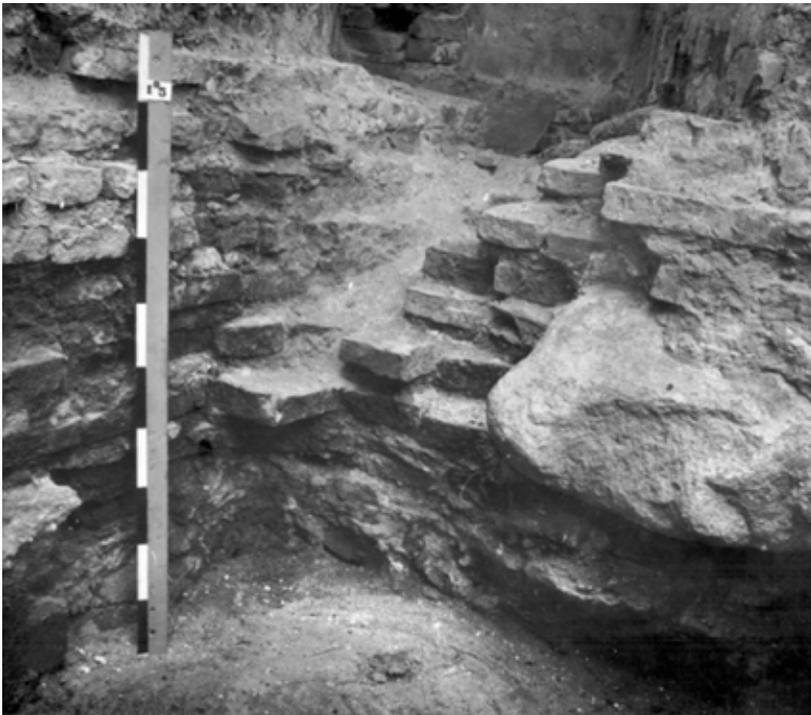
Fig. 7: Ruins of old foundation masonry of *St Michael's Golden-Domed Cathedral*. Photo: [in:] Collection of the Ukrrestavratsiia Corporation

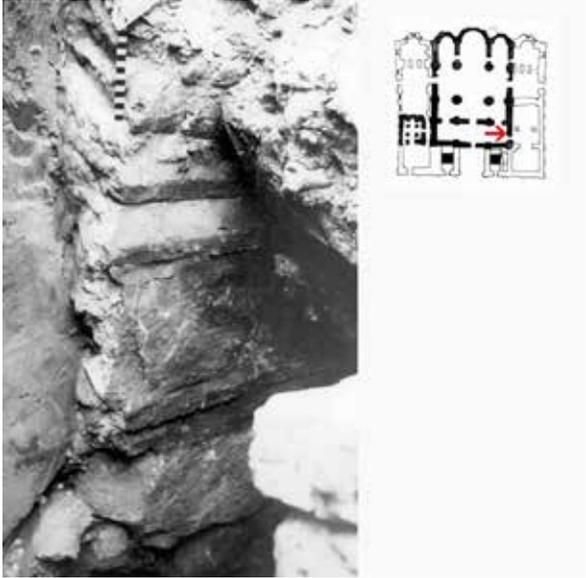
Fig. 8: *The Dormition Cathedral. Excavation site no. 18 a. East corner of the opening in the basement of the south wall of the narthex.* Photo: [in:] Collection of the Ukrrestavratsiia Corporation

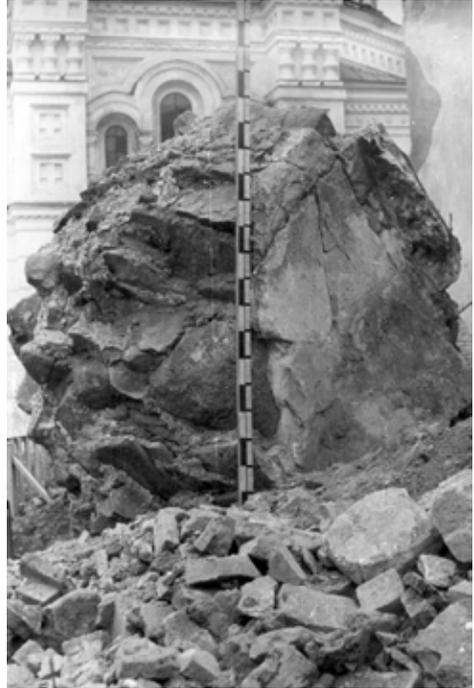
Fig. 9: *The Dormition Cathedral. Ruins of old masonry.* Photo: [in:] Collection of the Ukrrestavratsiia Corporation
