# Vita brevis, Ars longa – applied art and modernist architecture in Poland: Transformation of approach to applied art and contemporary protection

Sebastian Wróblewski

*Muzeologia a kultúrne dedičstvo*, 2022, 10:2:61-76  
DOI: 10.46284/mkd.2021.10.2.4

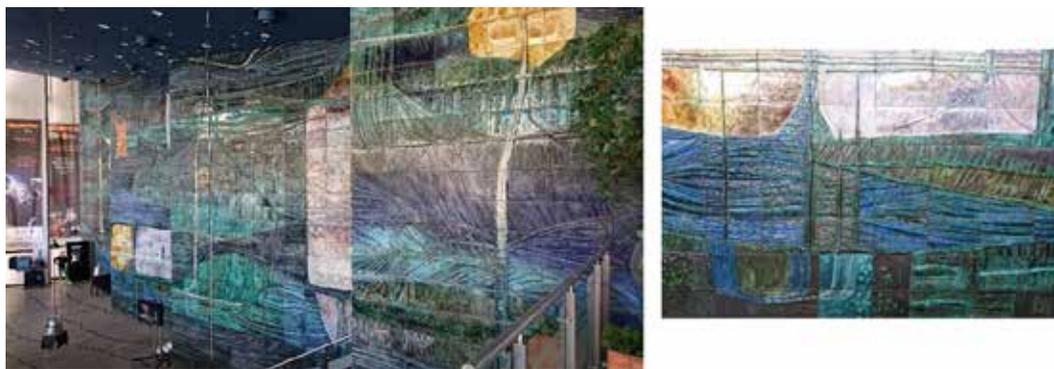
**Fig. 1:** Interior mosaic by Krystyna Zgud-Strachocka in Kijów Cinema in Cracow after restoration. General view and detail. 2016. Fot. Author

Modernist architecture could be inscribed into the register of protected monuments with all applied art forms as a coherent design, so any renovation action also has to be supervised by the local office of the state monument conservator. There are several cases in which a whole building with applied art has undergone a complete renovation after it was inscribed into the heritage monument register or shortly before that. One of the most elaborate designs is the Kijów Cinema in Cracow, designed by Witold Cęckiewicz with Jerzy Tombiński, Andrzej Kozłowski, Mieczysław Wrześniak, Adam Turczyński, Krystyna Strachocka-Zgud, Jerzy Chronowski and Jarosław Kosiniak in 1960–1967.<sup>18</sup> The inscription into the register was made in 2016.<sup>19</sup> However, in 2014, that modernist architecture was renovated, with changes made to the front façade window which had originally been designed to exhibit the spectacular mosaic wall in the main hall. The mosaics both in the hall and on the rear elevation were cleaned and renovated.<sup>20</sup> The interior mosaic is one of the greatest of its kind in Poland and since renovation has been covered with a special protective layer of a substance which is graffiti-proof. The mosaic is a masterpiece created by Krystyna Zgud-Strachocka in 1965.<sup>21</sup> It is an artwork of 325 m<sup>2</sup> surface made with ceramic, glazed tiles of semi relief forms. The author wanted to express the depth and beauty of space and used blue, turquoise and green patina colours which contrasted with the modernist white exterior and was visible especially in the night-time views through the façade window. The tiles were manufactured by the “Kamionka” cooperative factory of Łysa Góra near Brzesko, as were many other mosaic tiles from the southern Poland region and Cracow (Fig. 1). The external mosaic on the rear façade was

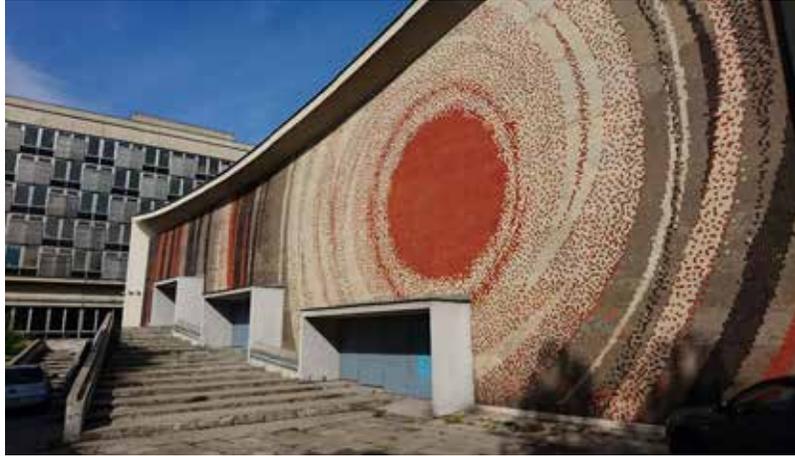
Fig. 2: Rear façade of *Kijów* by Witold Cęckiewicz after restoration. 2016. Fot. Author

designed by the architect himself in 1967 with typical factory-produced ceramic tiles, and in 2014 was also renovated and covered with impregnate.<sup>22</sup> A spectacular iconographic, mosaic image of a circular red sun on the elevation was contrasted with the white geometric solids of the architecture (Fig. 2).

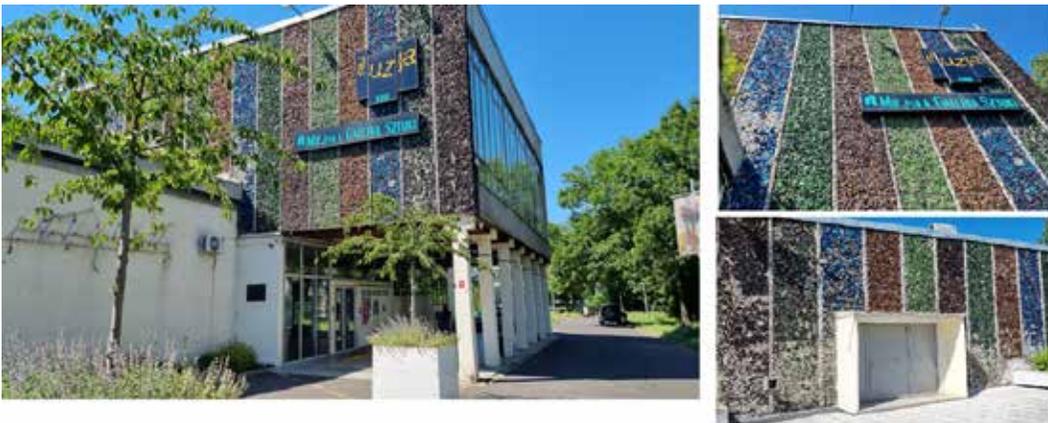
**Fig. 4:** The Cepelia and Bureau of Art Exhibitions (now City Art Gallery) in Częstochowa. 2021. General view and detail of deteriorated façade mosaic by Włodzimierz Ściegienny. Fot. Author

artists,<sup>26</sup> it is threatened with demolition. Also, the mosaic is in a state of deterioration due to a lack of conservation (Fig. 4). The conservation of such mosaics – made from 3D fragments of shattered glass or irregular stones – requires much more complicated conservation work. Such mosaics are more vulnerable to climate. The base strata of the underlay, which is usually also welded, is the first part to repair. All the “pieces” of mosaic are more unique than typical tesserae and therefore harder to replace. However, modern techniques of conservation allow even complicated 3D mosaic surfaces to be covered with protective strata. In the case of more “typical” mosaics made from ceramic tiles or ceramic fragments, the glaze is usually damaged due to processes of deterioration. In communist times artists used factory made products of low technical quality (though even with the famous “Kamionka” tiles, after a few decades with no conservation the surface layer of glaze might be damaged). If the factory’s ceramic is

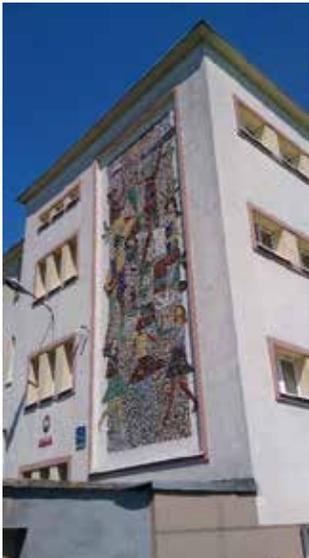
**Fig. 5:** *School façade mosaic by Stanisław Łyszczarz in Czestochowa after modernisation works. 2016. Fot. Author*

A rising level of social awareness allows the preservation of applied art forms in cases where the architecture is not unique, so does not have to be protected, but needs restoration and adaption to modern requirements, such as to contemporary thermal specifications. For example, in the Czestochowa school building (Szkola Podstawowa nr 21, Sabinowska 7/9 St.) of the 1930s, a thermo-isolation system was planned and a part bearing a mosaic of the local artist Stanisław Łyszczarz from the 1970s<sup>27</sup> was saved on the façade and “framed” with a new form (Fig. 5); although there were no legal regulations protecting the artwork the value of the mosaic was appreciated by officials and local society alike. A similar action with more modern additions being made to older architecture was performed in Tarnowskie Góry city. During the recent renovation of Tarnowskie Góry Cultural Centre, the main façade was largely rebuilt; however, this was carried out with the exposition of a mosaic by Stefan Suberlak from 1973,<sup>28</sup> which in its new architectural frame was highlighted and illuminated (a mosaic by Jan Nowak in the interior also being renovated and exhibited).

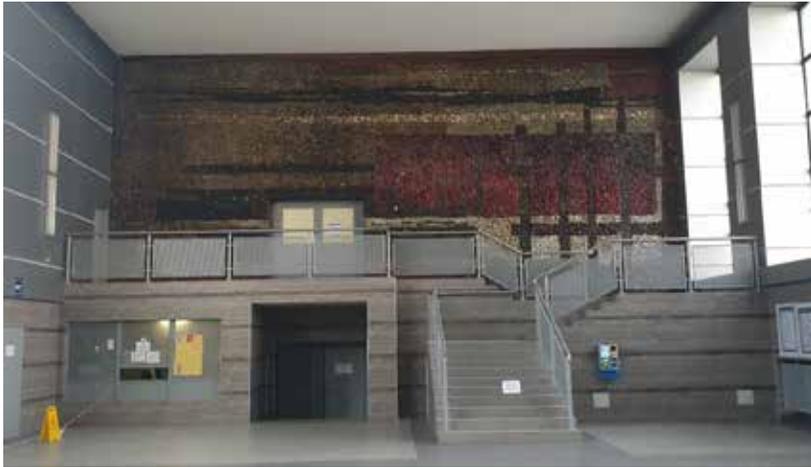
**Fig. 6:** Bytom – railway station hall after restoration with mosaic by Kazimierz Gąsiorowski. 2021. Fot. Author

elements despite the protests of local society.<sup>34</sup> A major mosaic was illuminated and installed in the modern interior. In Szczecin the building of the main railway station was not a modernist construction but was only redecorated in the 1970s, and a similar operation was performed in Bytom railway station. There, in the hall of the railway station from the 1930s, Kazimierz Gąsiorowski made a large mosaic on the side wall in the 1960s.<sup>35</sup> The composition is abstract with distinct red squares made of glass contrasting with brown, white and black stones. An asymmetry was underlined by placing red parts to the right side of the mosaic and a contrast made between rectangular shapes and amorphous cloudy forms. In 2017 a renovation of the hall was performed with the cleaning of the mosaic, which became, as in Szczecin, a major artwork of the building focusing the interest of spectators. New decoration of the interiors was tailored to the horizontal composition of Gąsiorowski's work with stripes of wall panels and paintings of sharp straight lines making a contrast with the more amorphous composition of the mosaic (Fig. 6).

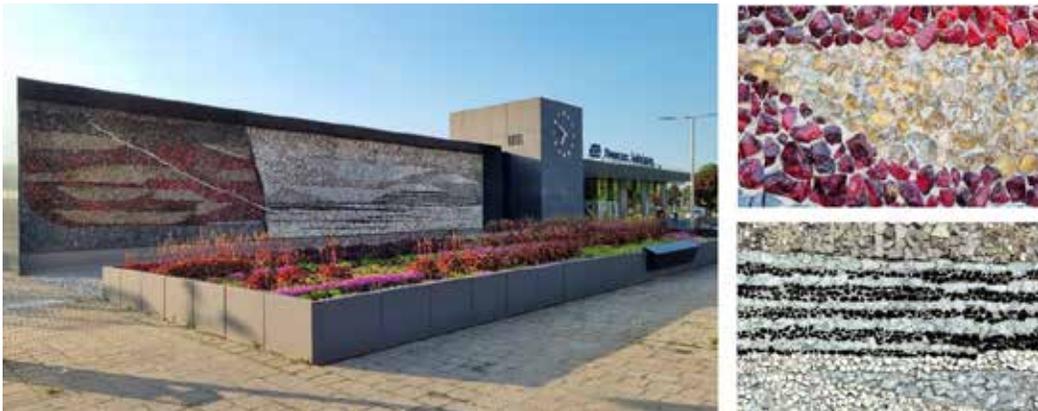
**Fig. 7:** Oświęcim – new building of the railway station with mosaic by Kazimierz Gąsiorowski. 2021. General view and detail of restored artwork. Fot. Author

Kazimierz Gąsiorowski was also the artist who created in the same iconographic stylistics a mosaic for Oświęcim railway station in 1964–65.<sup>36</sup> The artwork of 4.6 m height and 24 m length weighed 100 tons and was designed for the modernist building rebuilt in 1962 by Karol Fojcik,<sup>37</sup> where it was displayed above the cash registers, opposite the entrance. The main façade was of glass wall, which also like in Cracow's Kijów cinema had allowed, before demolition, the exposition of internal artwork, which was not inscribed into the register of monuments but was saved during the process of the redesigning and rebuilding of the new railway station. The new building was opened in June 2020 and it is an original and spectacular, contemporary work of architecture closely connected with Gąsiorowski's art. The mosaic was 3D scanned and cut into four sections with the background. Conservation brought back the original colours after the cleaning. The artwork was created from black, grey and white stones and shattered glass in intensive red, black and white colours. Like in Bytom's artwork, it is mostly abstract in its composition (although in the case of Oświęcim the red part might have symbolic meanings and there is no strict rectangular composition of shapes but more cloud-like, smooth figures), underlining horizontal lines, which suits contemporary modernist buildings. The architect Paweł Kośmicki designed the new building with a perfect exposition of the mosaic, which is protected by roof shading. In the case of Oświęcim railway station there is another unique solution – a layout of greenery in front of the mosaic has been designed by the landscape architect Marzena Świtalska. The pattern of the greenery is carefully accordant to the composition of the mosaic. The new railway station has become an open-air gallery in which the applied art serves its original purpose – the public, egalitarian presentation of art – and is a spectacular architectural monument dedicated to the victims of the nearby Auschwitz German Nazi Concentration Camp (Fig. 7).

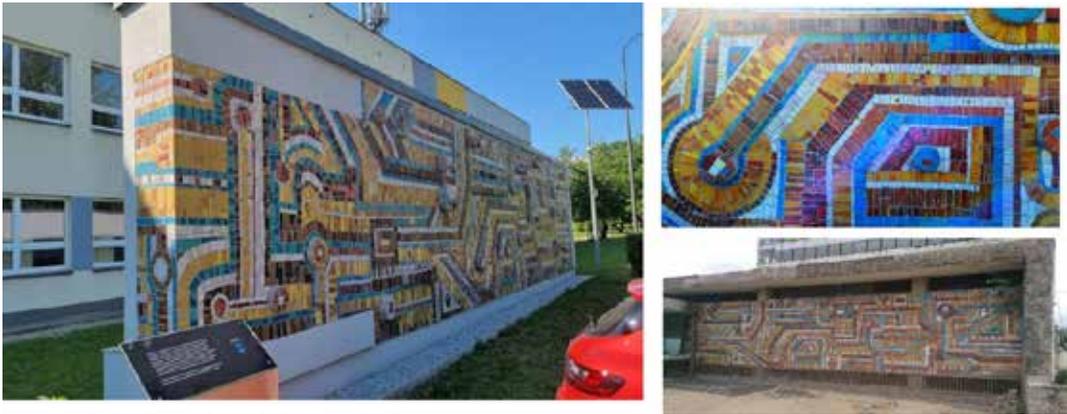
**Fig. 8:** Tychy. General view before transfer (lower right) and restoration works in 2016 and current exposition of artwork by Franciszek Wyleżuch in 2021 with renovated detail. Fot. Author

undertaken the precious artwork inscribed into the register of monuments was cut off the wall, conserved and transferred to a new location at the front of the school in Tychy (Zespół Szkół nr 4, al. Bielska) where it was arranged in the form of a free-standing wall-sculpture with information and night illumination. The new arrangement allows the artwork to be appreciated; however the presentation of that art as a free-standing sculpture in front of a parking lot does not fully do it justice (Fig. 8).
