Synagogue Decorations in Present-Day Ukraine: Practice in Preservation of Cultural and Artistic Heritage

*Muzeológia a kultúrne dedičstvo, 2020, 8:4:111-136
DOI: 10.46284/mkd.2020.8.4.8*

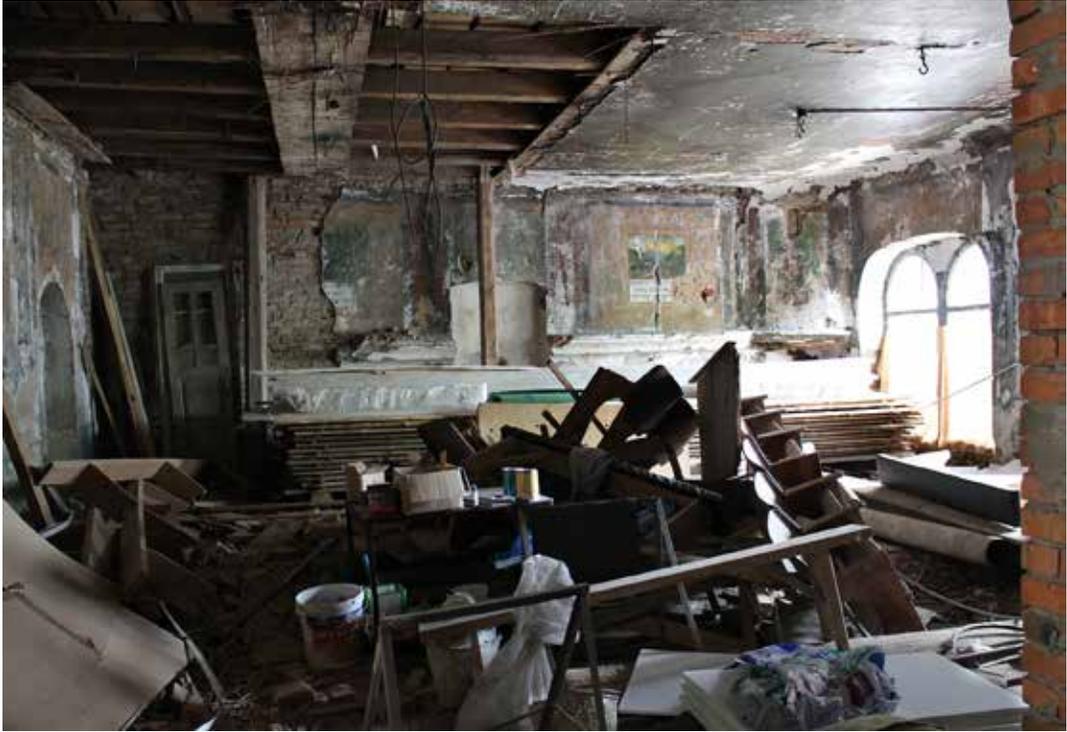
Figure 1: Chernivtsi. *Chevre Tehilim Synagogue, turn of twentieth century.* Photo by Anna Yamchuk, 2015

may, with painstaking efforts, be able to discern certain narrative compositions and partly envision the painting scheme as a whole (Figure 1).¹⁰ These historic paintings are disintegrating before our very eyes as the second storey, where the prayer hall of the synagogue was once situated, is constructed anew.

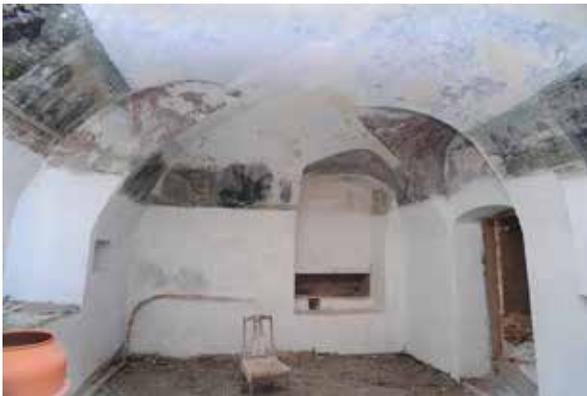
Figure 3: *Chernivtsi. The minor hall of the synagogue Groyse Shil. Wall paintings, late 1930s. Discovered in 2013.* Photo by Anna Yamchuk, 2015

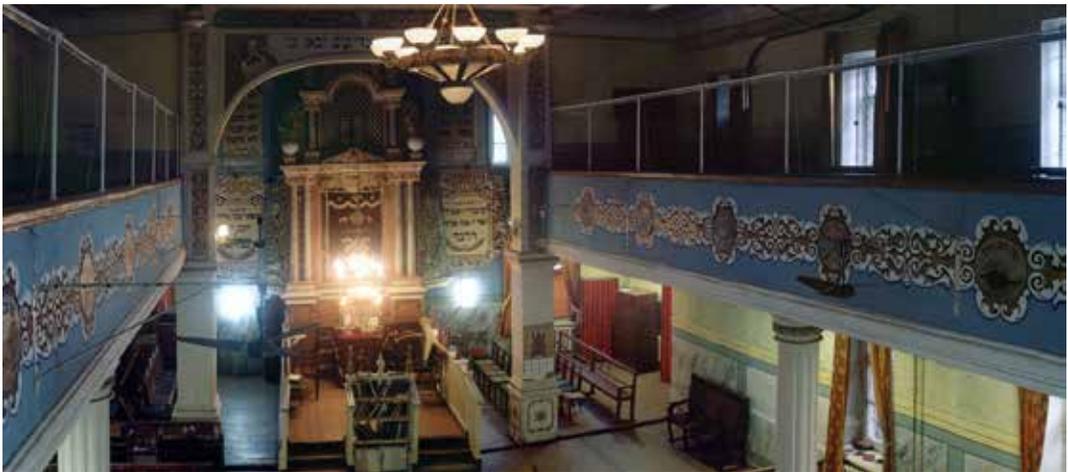
Figure 4: *Kyiv. Schekovitzka (Podol) Synagogue, 1895. Wall paintings, mid-twentieth century.*
Photo by Eugeny Kotlyar, 1997

This approach was resorted to in the reconstruction of Schekovitzka Synagogue in Podol, Kyiv, built in 1895.²³ The wall paintings surviving to date, according to the testimony of its oldest members, are from the mid-1900s. The last refurbishment took place in 2003, when the building as a whole was reconstructed (Figure 4, 5).²⁴

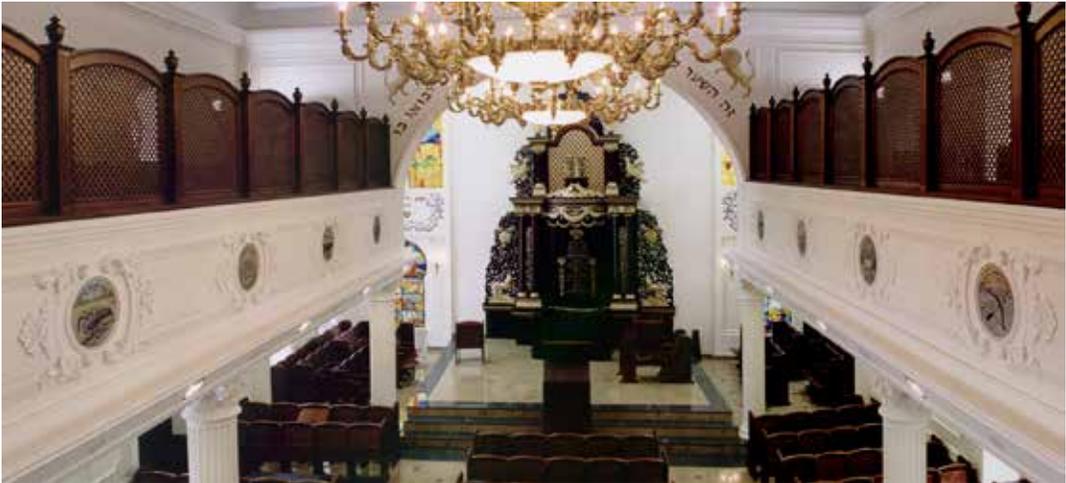
Figure 5: *Kyiv, Schekovitzka (Podol) Synagogue, 1895. Wall paintings, mid-twentieth century. Refurbished in 2002. Photo by Eugeny Kotlyar, 2003*

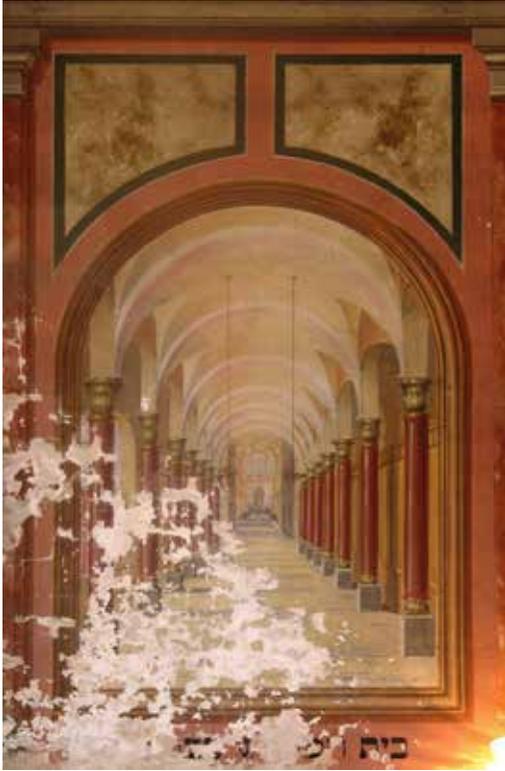
Figure 6: *L'viv. Tzori Gilead Synagogue. Wall paintings, 1930s.* Photo by Eugeny Kotlyar, 2006

This approach can be seen in the case of the functioning Tzori Gilead Synagogue in Lviv, which was built in 1924. Up until 2006, the year when it was last comprehensively renovated, the building preserved its painting decoration, which dated from 1936 and was created by the

well-known Lviv master, Maksimilian Kugel. Even though the paintings were damaged during the years of Nazi occupation, and later when the building was used as a storage facility, the losses suffered were not so serious that they ruled out traditional restoration methods – which was, in fact, the approach adopted by the synagogue's decision-makers.²⁵

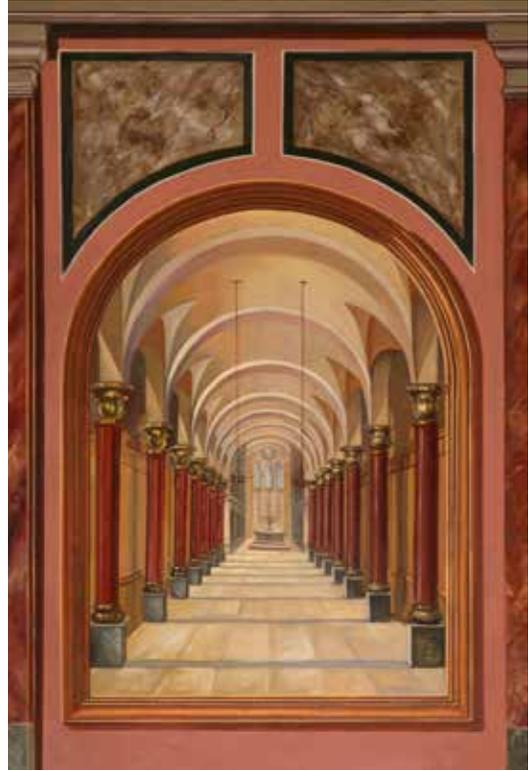
Figure 7: *L'viv. Tzori Gilead Synagogue. Wall paintings, 1930s. Refurbished the old paintings in 2006.* Photo by Eugeny Kotlyar, 2012

The purpose of the reconstruction was to renovate the prayer hall so as to accommodate the needs of the contemporary community. This is why, in addition to the repair work done on the facility and the replacement of the furniture, lighting fixtures and other equipment, the community leaders also refurbished the old paintings, aiming to preserve the historic ambiance and endow the interior with an aura of respectability. Authentic paintings were completely destroyed as a result: the artists simply did the paintings anew, in the process altering compositions and inscriptions which had been partly lost and using a different painting style and colour contrasts which were far in excess of the original. Thus, in the reworked composition, the view of the interior of the Temple in Jerusalem lost the inscription which once sat under it (Figures 6, 7), while the image of the Ark containing the Tablets of the Law was replaced by a *menorah*. Community leaders had evidently found it simpler to redo old compositions than to devote effort to the painstaking and costly process of restoration, which would in any case have produced less of an effect than the new paintings. This case instantiates the general rule that a functioning synagogue cannot be a museum; it is illustrative of the real dilemma between preserving a historical landmark as a museum piece of sorts, and restoring it so as to make

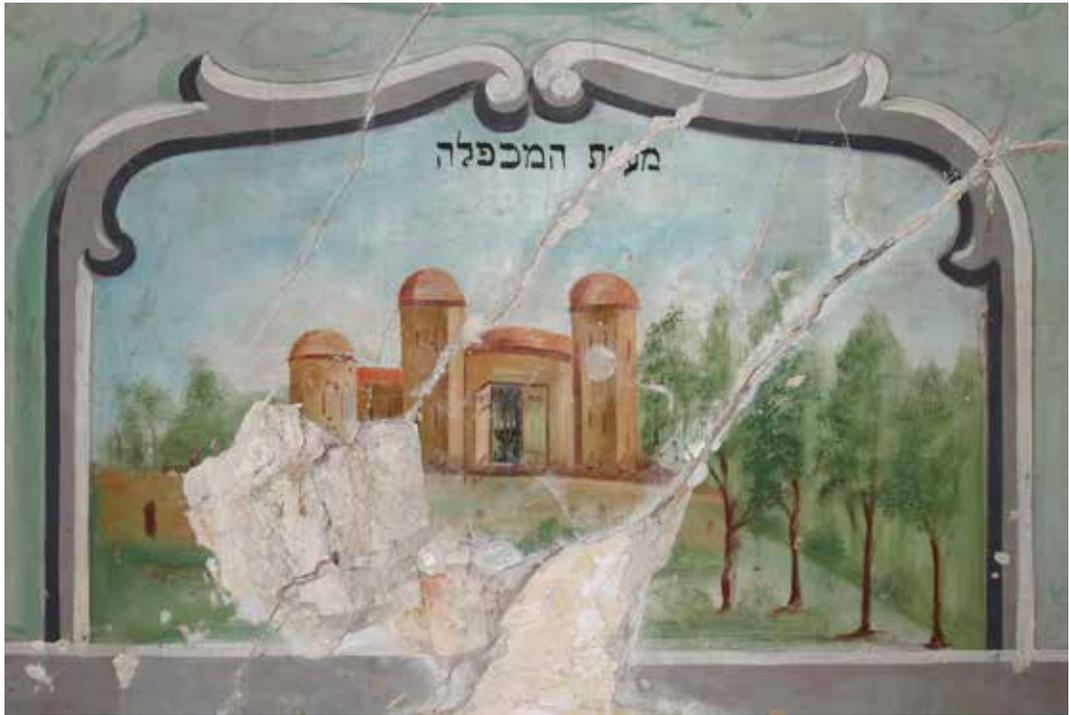
Figure 8: *Novoselitsa. New Great Synagogue. The Tomb of the Patriarchs in Hebron: wall paintings, 1919–1920. Discovered in 2009. Photo by Eugeny Kotlyar, 2010*

The only example of this approach is the case of the paintings in the abandoned Novoselitsa synagogue, which were discovered under the whitewash in 2008 and made fully visible a year later by Kyiv renovators.³⁰ The purpose of clearing away the most recent layers of plaster from the painting stratum was the desire to make the unique find, miraculously preserved, visible as soon as possible. Following the cleaning, the paintings were uncovered using a solution of

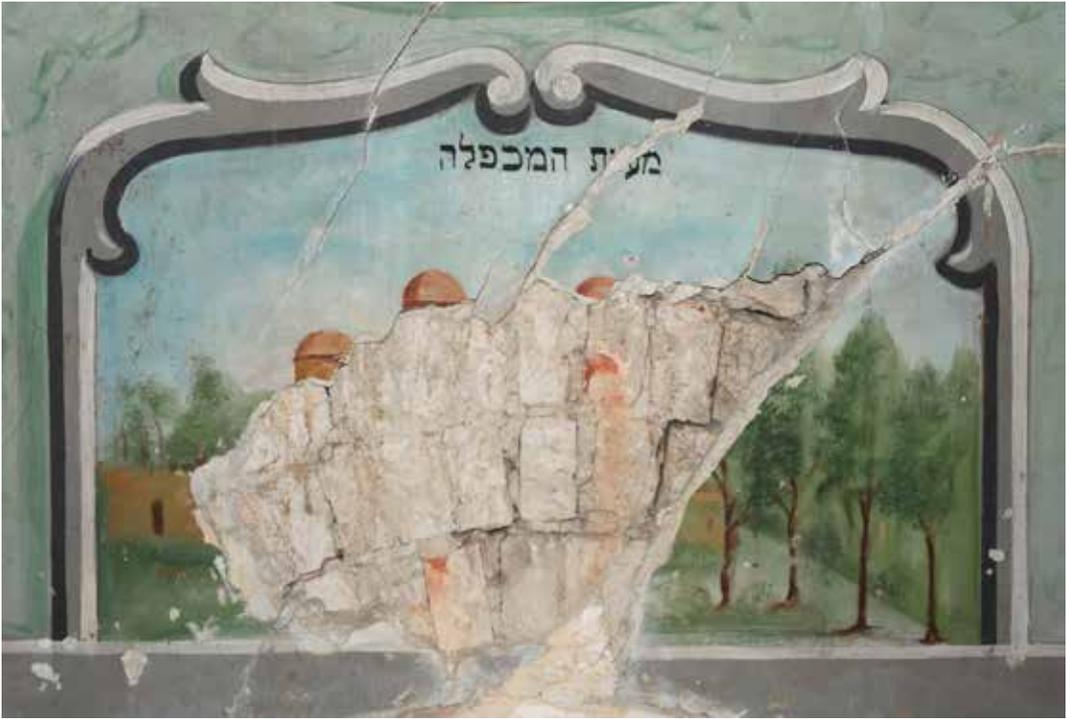
Figure 9: *Novoselitsa. New Great Synagogue. The Tomb of the Patriarchs in Hebron, wall paintings, 1919–1920.* Photo by Anna Yamchuk, 2015

pinene and plant oil, thus recovering the images' original vividness. The work was performed in a professional manner, and achieved its goal. But the outcome was that the paintings were left exposed, whereas previously the uppermost layer of chalk had, for many decades, protected them from destruction. Debates and discussions about putting the ensemble on display in the future have not yielded any conclusive results. One of the options, proposed by the private owner of the building, was to conserve the paintings in the same building, which was intended to serve as a cultural institution after renovation. A second option, put forth by Jewish agencies, was to transfer the stratum with the paintings to Chernivtsi, the regional capital, which has an active Jewish community and a museum – in fact, a variety of institutions generating a “museum-going stream” of visitors. Settling on a solution involves tackling questions of an organizational, financial and technical nature which apparently still remain open. Today, thanks to the dilapidation of the building, the paintings are in a critical condition; some of the fragments have been lost forever (Figures 8, 9). The building's owner, concerned about the prolonged inaction, has meanwhile started renovation work on his property on his own. At present it is difficult to guess what this monument's fate may be.

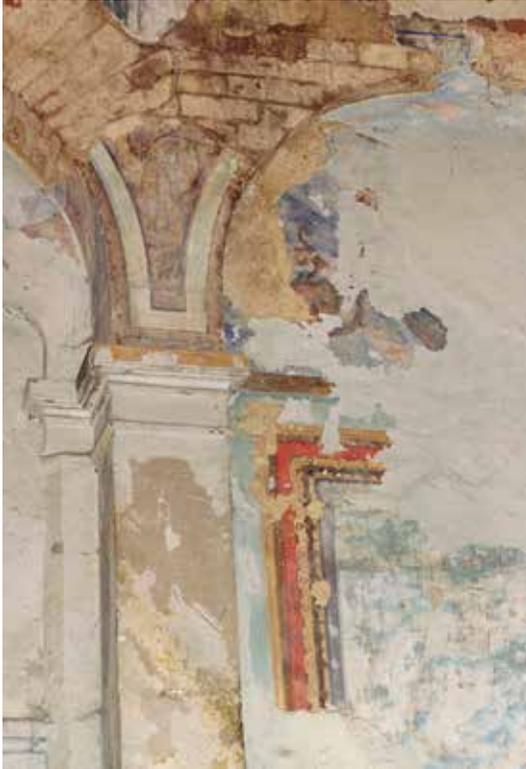
Figure 10: *Sadygora (now part of Chernivtsi). Former Rabbi Israel Friedmann's Synagogue. Traces of wall-paintings in the ruined building.*
Photo by Eugeny Kotlyar, 2002

the question of restoring the centre of Sadygora Hasidism for pilgrims who are also followers of the movement.³¹ The very meagre material that remained for the renovators to draw on from the former luxuriously decorated synagogue of one of the most powerful nineteenth-century Hasidic *tzaddiks* meant it was only possible to form only an overall sense of the styles and the colour schemes used in the decorative wall paintings, and to take in little more than the spirit of the ornamentation. Fragments of painted engaged frames and curved ribbon-like shafts with their inner fields partly filled with climbing acanthus were adopted as basic motifs from the old decoration in creating the new paintings. This part of the decoration, reconstructed from the legacy of the past, also dictated the general colour scheme (Figures 10, 11). The scheme was thoroughly integrated into the new design of the interior, which combined traditional elements with postmodernism. Aharon Ostraikher, mentioned above in connection with the restoration of Schekovitzka Synagogue, used the motif of a blue sky with clouds, executed in a photorealistic manner, to decorate the coffered ceiling. This modern approach was combined with traditionalist stained-glass windows on the theme of the Twelve Tribes of Israel by the Chernivtsi artist Anatoly Fedirko.

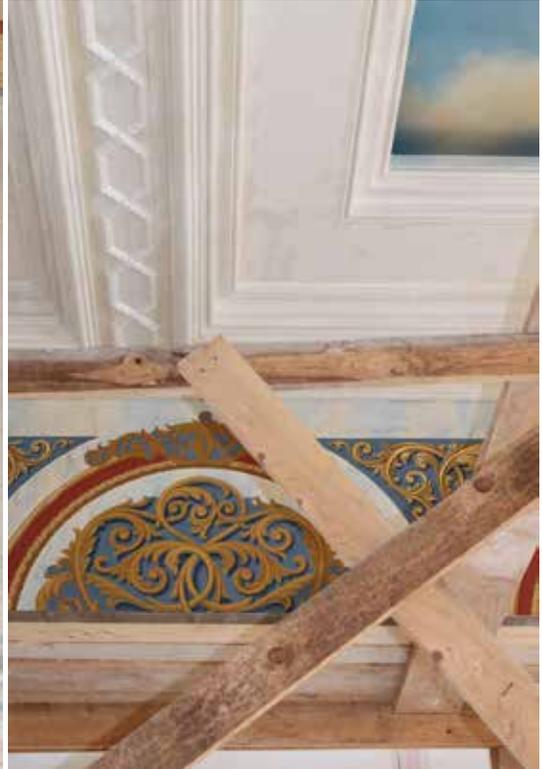
Figure 11: *Sadygora (now part of Chernivtsi). Rabbi Israel Friedmann's Synagogue. A new synagogue decoration.*
Photo by Eugeny Kotlyar, 2016

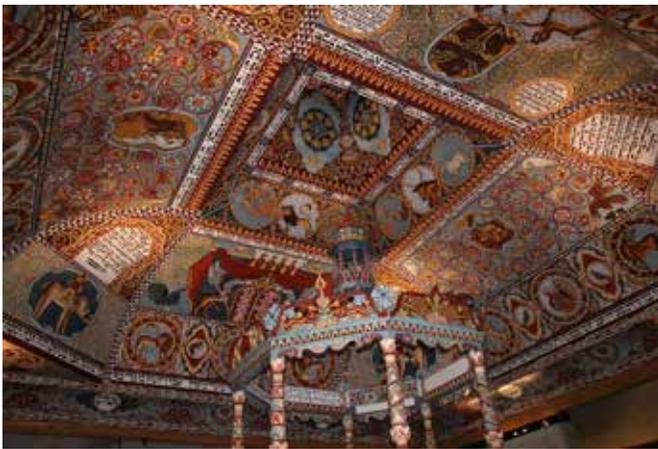
Figure 12: Replica of the *bimah* and vault paintings from Gvizdetz Synagogue. Warsaw: POLIN Museum of the History of Polish Jews. 2013–2014. Photo by Eugeny Kotlyar, 2014

This approach can be traced in two well-known copies of synagogue wall paintings from the first half of the eighteenth century, recreated using wooden constructs. These are replicas of the ceiling paintings from the Khodoriv Synagogue (1977, James Gardner Studios, London) stored in the Diaspora Museum in Tel Aviv, and the vault and *bimah* paintings from Gvizdetz (2011–2014, Handshouse Studio, Norwell, US)³² at the POLIN Museum of the History of Polish Jews in Warsaw (Figure 12).³³ Both synagogues were formerly located in

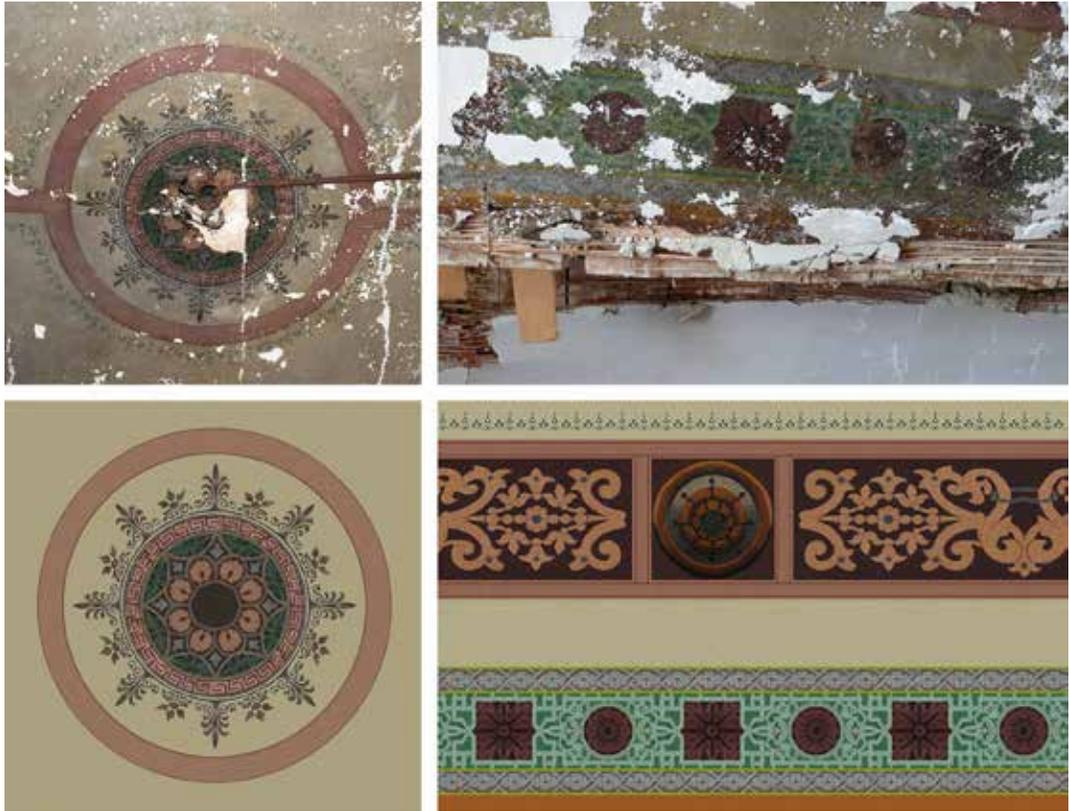
Figure 14: *Chernivtsi. Chevra Tehilim Synagogue. Digital reconstruction of the damaged ceiling paintings.* Computer graphics by Eugeny Kotlyar, 2015

as in the ruins of Beit Tehilim Synagogue in Chernivtsi, we were able to reconstruct part of a painting that had been all but lost. Certain elements of the painting were recreated based on the surviving details of the ceiling decoration; from this, the original appearance of the painted ceiling re-emerged (Figure 14). Superimposing the lost fragments upon the result produced a photo display which enabled the viewer to envision the ceiling in its original form (Figure 15) and appreciate its condition at present. Similar work on other parts of the paintings enabled us to recreate the painting scheme, except where compositions had been completely lost. The same kind of work was carried out for other synagogues which were in varying states of dilapidation. The result was a comprehensive exhibition catalogue³⁶ and a transformable mobile display.

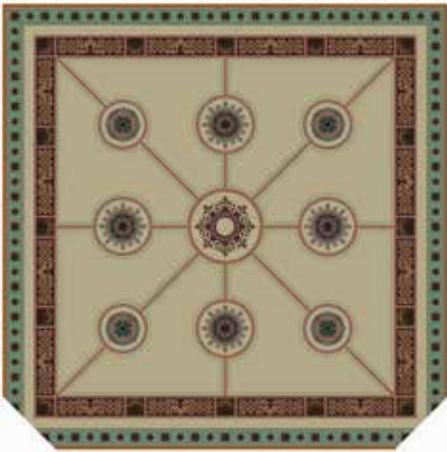
Figure 15: *Chernivtsi. Chevra Tehilim Synagogue. Digital reconstruction of the ceiling paintings. Computer graphics by Eugeny Kotlyar, 2015*

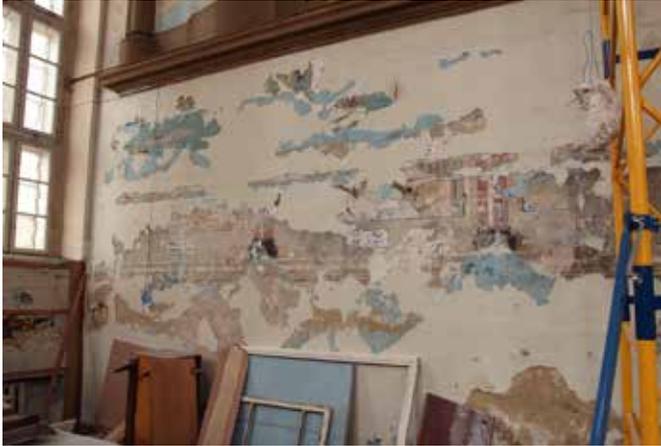
Figure 17: Lviv. Yakub Glanzer's Shul Synagogue, 1844. Traces of wall-paintings in the ruined building.
Photo by Eugeny Kotlyar, 2016

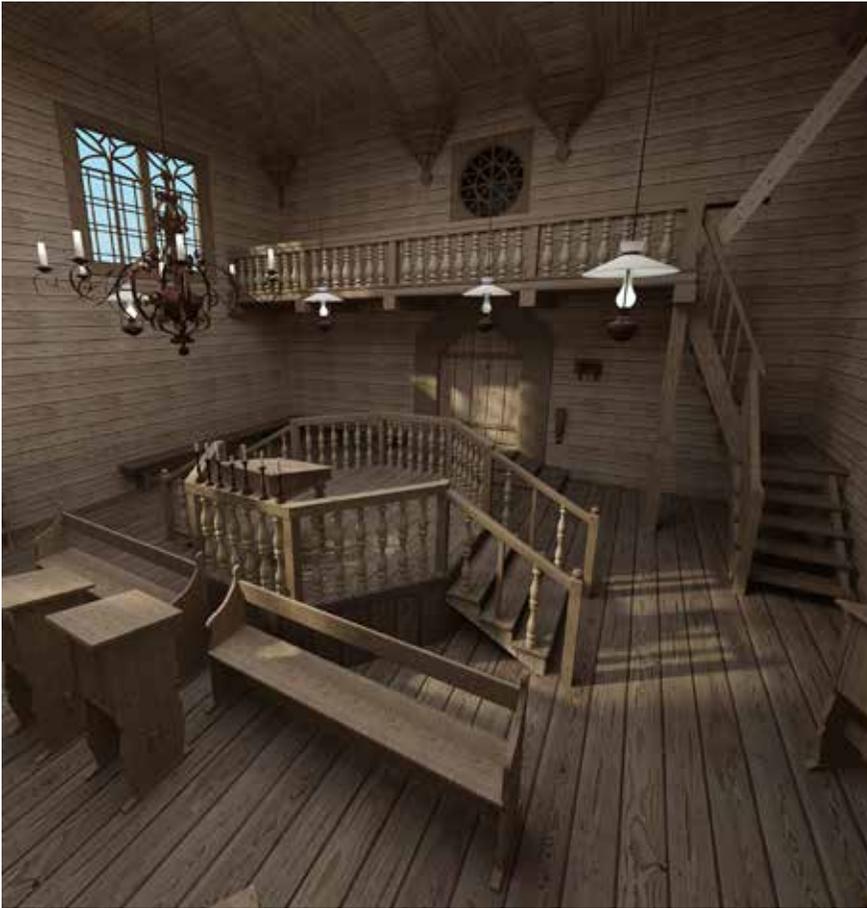
Figure 18:
A digitised model of the interior of the wooden synagogue in Smotrych, mid-eighteenth century. Model by Sergey Biryukov and Eugeny Kotlyar, 2011
